# Four Types of Heat Exchanger Failures

. . . mechanical, chemically induced corrosion, combination of mechanical and chemically induced corrosion, and scale, mud, and algae fouling

By **MARVIN P. SCHWARTZ**, Chief Product Engineer, ITT Bell & Gossett  
a unit of Fluid Handling Div., International Telephone & Telegraph Corp., Skokie IL

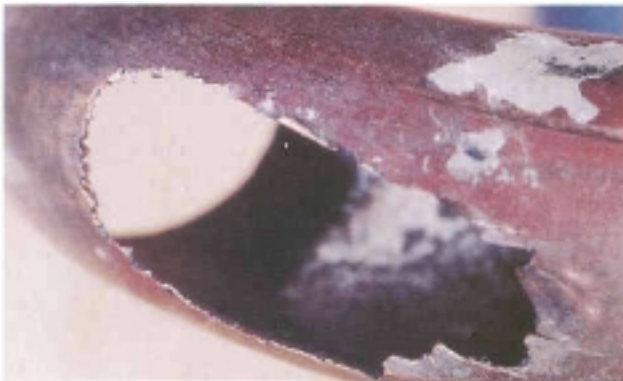
Most metal erosion problems occur inside the tubes. The U- bend of U-type heat exchangers and the tube entrances are the areas most prone to erosion. Figure 1 shows the metal loss in a U- bend caused by high temperature water flashing to steam.

Fig. 1. Metal erosion in U bend.

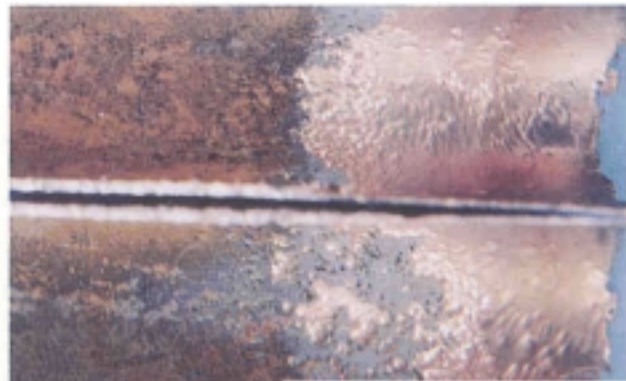
Tube entrance areas experience severe metal loss when high-velocity fluid from a nozzle is divided into much smaller streams upon entering the heat exchanger. Stream dividing results in excessive turbulence with very high localized velocities. High velocity and turbulence produce a horseshoe erosion pattern at the tube entrance. Fig. 2.

Fig. 2. Metal erosion at tube entrance.

Maximum recommended velocity in the tubes and entrance nozzle is a function of many variables, including tube material, fluid handled, and temperature. Materials such as steel, stainless steel, and copper-nickel withstand higher tube velocities than copper. Copper is normally limited to 7.5 fps; the other materials can handle 10 or 11 fps. If water is flowing through copper tubing, the velocity should be less than 7.5 fps when it contains suspended solids or is softened.

Erosion problems on the outside of tubes usually result from impingement of wet, high-velocity gases, such as steam. Wet gas impingement is controlled by oversizing inlet nozzles, or by placing impingement baffles in the inlet nozzle.

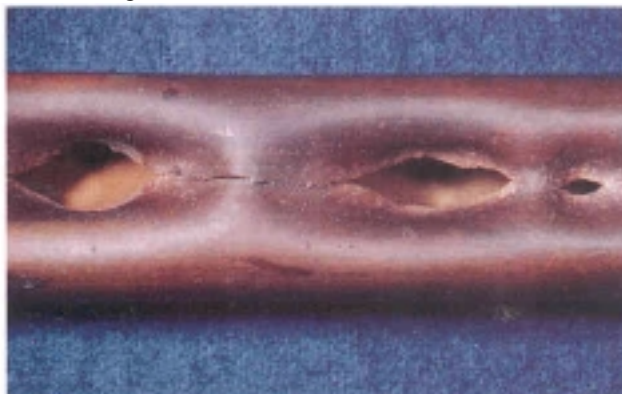
Vacuum breaker vents must be provided if condensables are handled in either the shell or tubes; they prevent steam hammer damage resulting from condensate accumulation. Figure 3 shows typical tube damage caused by steam hammer. In this case, condensate accumulated in the shell and rapidly accelerated, producing a high-pressure shock wave that collapsed the tube and caused the tear holes.

Fig. 3. Tube damage from steam

Properly sized steam traps with return lines pitched to a condensate receiver or condensate return pump should be installed to prevent this type of damage.

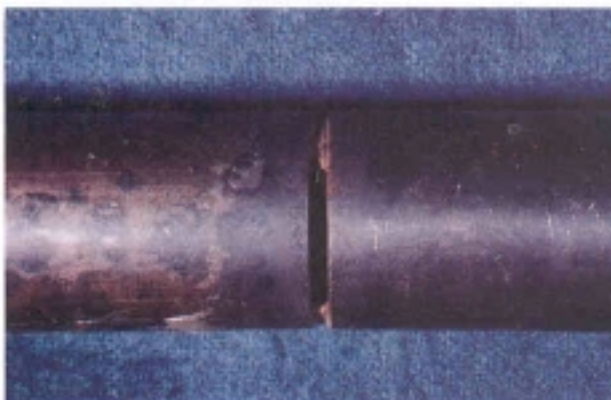
Shell-side fluid velocities in excess of 4 fps can induce damaging vibrations in the tubes, causing a cutting action at support points with baffles. Fig. 4. Velocity-induced vibrations can also cause fatigue failures by work hardening the tubing at baffle contact points or in U-bend areas until a fatigue crack appears.

Fig. 4. Velocity-induced vibration cut of tube.

**Vibration**-Excessive vibration from equipment such as air compressors or refrigeration machines can cause tube failures in the form of a fatigue stress crack or erosion of tubing at the point of contact with baffles. Heat exchangers should be isolated from this type of vibration.

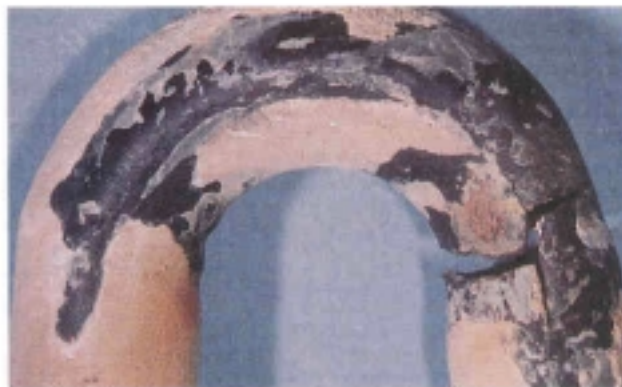
**Thermal Fatigue** --Tubing, particularly in the U- bend area, can fail because of fatigue resulting from accumulated stresses associated with repeated thermal cycling. This problem is greatly aggravated as the temperature difference across the length of the U-bend tube increases.

Figure 5 shows an example of thermal fatigue. The temperature difference causes tube flexing, which produces a stress that acts additively until the tensile strength of the material is exceeded and it cracks. The crack usually runs radially around the tube, and many times results in a total break. In other cases, the crack occurs only halfway through the tube and then runs longitudinally along it.

Fig. 5. Thermal fatigue failure in U bend.

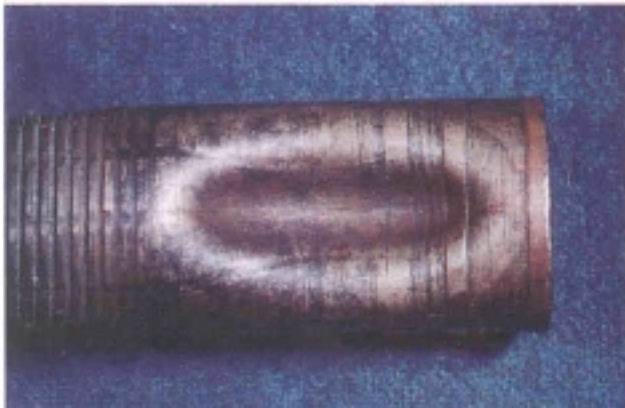
For example, assume a chiller has improper settings or malfunctioning controls that cool the water to a point below its freezing point. Ice forms and exerts tremendous pressure in the tubing, which causes it to rupture or collapse. Collapse in an evaporator, Fig. 6, usually occurs near the tube sheet where the tube is not protected by an inner splint.

Fig. 6. Collapse of evaporator tube because of freeze-up.

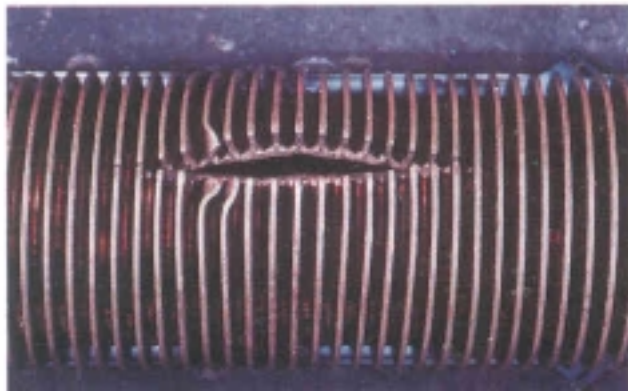
Freeze-up failure in a condenser tube is shown in Fig. 7. In this case, cooling water was circulating inside the tube, refrigerant was condensed on the externally finned surface, and the unit was not properly drained for winter shutdown. The tube distortion indicates that it was exposed to excessive pressure caused by the freezing water.

Fig. 7. Rupture of condenser tube because of freeze up.

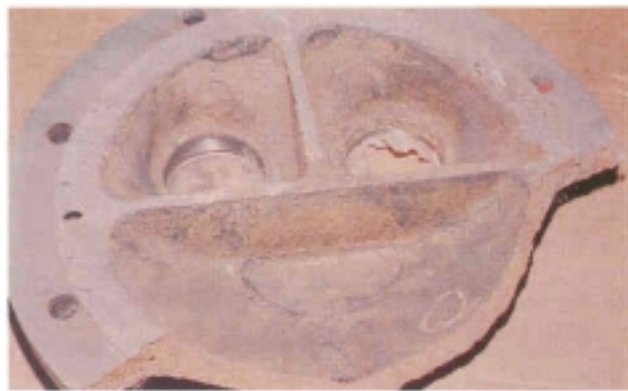
In steam-heated systems, cooling down or condensing residual steam in the shell after the steam control valve closes continues to heat water or other fluids on the tube side. Continued heating causes thermal expansion, which creates pressures far in excess of the strength of tube sheets, cast heads, and other heat exchanger components. Cast iron parts usually fracture because of lack of ductility: steel tube sheets become bowed or permanently distorted because the material's yield point is exceeded. Figure 8 shows thermal expansion failure of a cast iron heat exchanger head.

Fig 8. Thermal expansion failure of cast iron head.

Relief valves are installed in the heated fluid system to prevent this kind of failure. It is also advisable to provide some means to absorb fluid expansion. For example, installing a tank in the heated fluid system prevents periodic discharge of relief valves, which results in loss of system fluid and places an undue burden on the valve. These devices are installed between the heat exchanger and any shutoff or control valves.

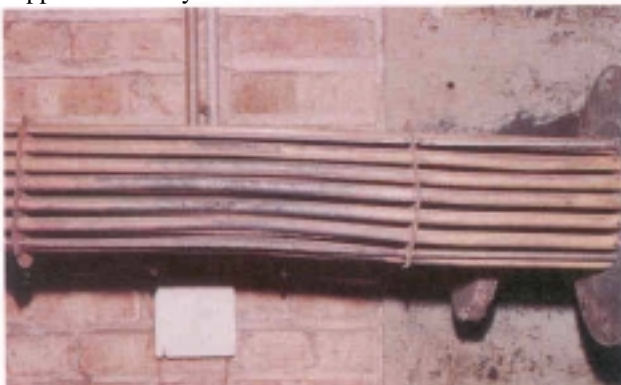
Figure 9 shows the tube warping that results without enough cooling fluid. Temperature actuated modulating control valves should be used to regulate cooling liquid flow.

Fig. 9. Tube Warping because of insufficient cooling water

*Loss of Cooling Water*-Compressed air aftercoolers and gas coolers should always have a supply of cooling fluid before a flow of hot gas is started. High gas temperatures melt or warp the tubing if there is not an adequate supply of cooling fluid.

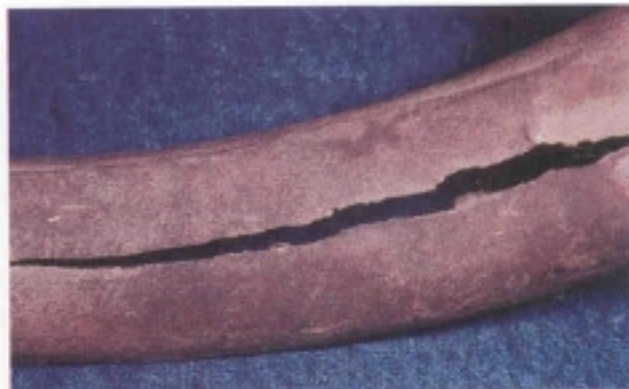
*General Corrosion* -- This type of corrosion is characterized by a relatively uniform attack over the tube, tube sheet, or shell, and there may be no evidence that corrosion is taking place. Figure 10 shows a tube that became so thin it actually tore down the middle.

Fig. 10. Thinning of tube because of general corrosion.

Selecting a material with adequate corrosion resistance for its environment, along with using proper treatment chemicals, maximizes heat exchanger life.

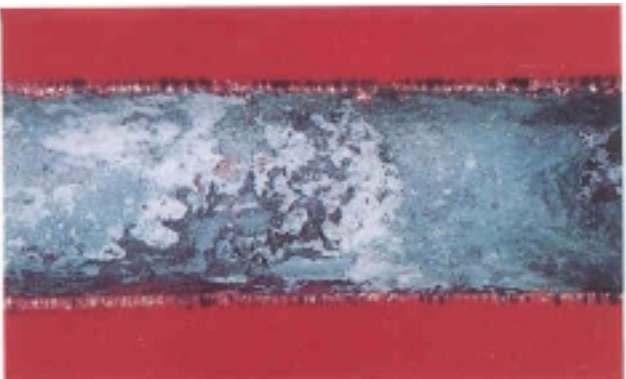
Fairly stable aggressive conditions generate this type of attack. Low pH (less than 7) combined with carbon dioxide or oxygen produces the attack on copper. The blue or bluish-green color on the tubes in Fig. 11 shows the results of carbon dioxide attack on the inside of a copper tube. Various chemicals, such as acids, also produce this type of metal loss.

Fig. 11 General corrosion inside copper tube because of CO<sub>2</sub>.

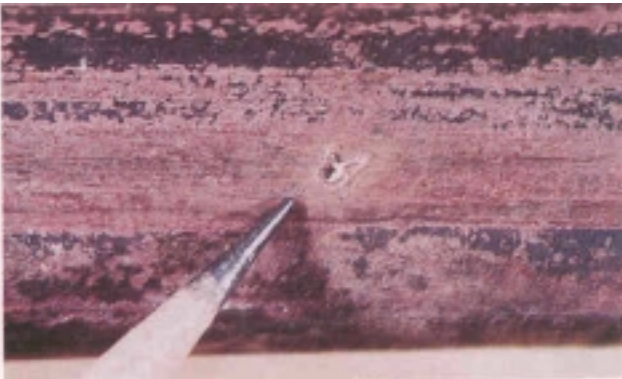
Figure 12 shows an oxygen pitting attack on a copper tube, and Fig. 13 illustrates a carbon dioxide pitting attack on a copper tube.

Fig. 12. Oxygen pitting attack on copper tube.

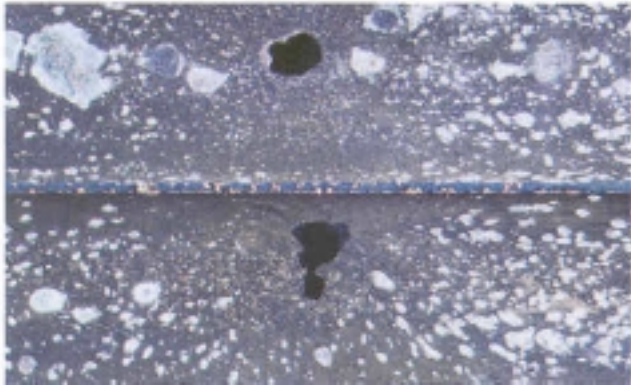
Fig 13. Carbon dioxide pitting attack on copper tube.

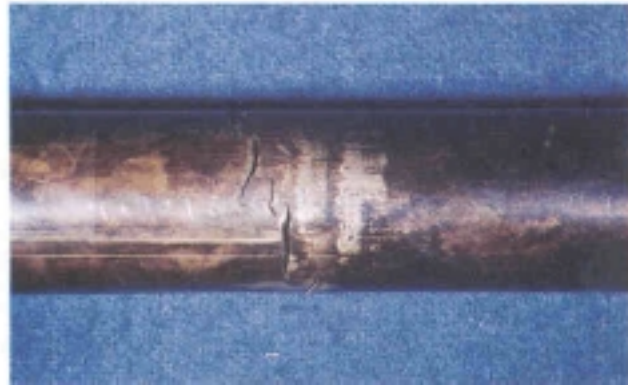
Failures from this corrosion take the form of fine cracks, which follow lines of stress and material grain boundaries. Figure 14 shows stress corrosion failure in admiralty tubing.

Fig. 14. Stress corrosion failure in admiralty tube.

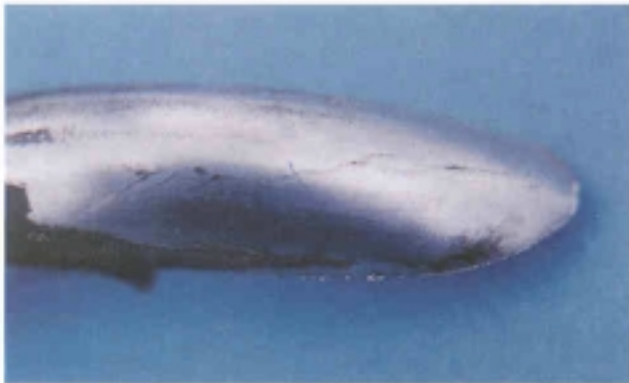
The corrodent that causes stress corrosion on stainless steel tubes is the chloride ion, which is potentially present in any compound formulated with chlorine. All naturally occurring waters contain the chloride ion in varying degrees. The chloride stress corrosion phenomenon is not well understood, but it is known that the frequency of occurrence rises with an increase in temperature and chloride ion concentration. Keeping tube wall temperatures below 115 F (calculated with maximum, not average, fluid temperatures) prevents stress corrosion cracking problems with chloride ion concentration up to 50 ppm. Figure 15 shows stress corrosion cracking in a type 304 stainless steel U bend.

Fig 15 Stress corrosion cracking in stainless steel U bend.

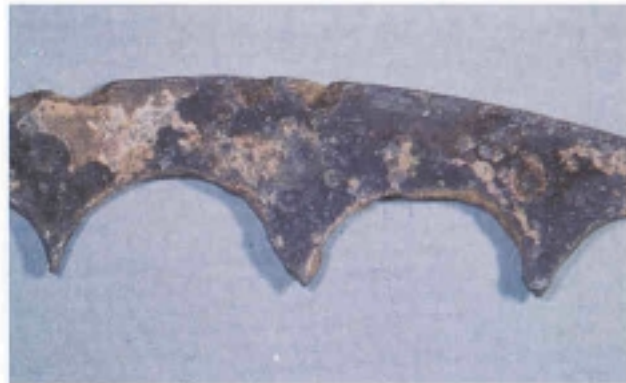
Figure 16 shows an example of galvanic corrosion on a steel baffle. In this case, the less noble steel baffle was sacrificed at its point of contact with the copper tubing

Fig. 16. Galvanic corrosion on steel baffle.

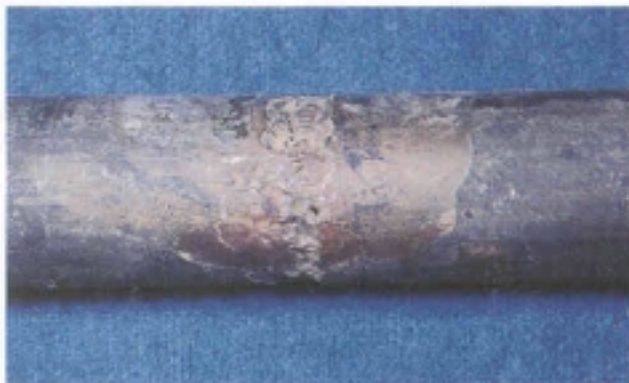
*Crevice Corrosion* -- This type of corrosion originates in and around hidden and secluded areas, such as between baffles and tubes, Fig 17, or under loose scale or dirt. A localized cell develops and the resulting corrosion appears as a metal loss with local pits, often giving the impression that erosion is taking place. This condition is in contrast to a vibration failure in which the metal is sharply cut and there are no pits. Relatively stagnant conditions must exist for crevice corrosion to occur.

Fig, 17. Crevice corrosion at contact between tube and baffle. Fig.18. Condensate grooving and pitting attack on tube.

The attack can often be controlled by making sure that velocities are adequate to prevent stagnation or the accumulation of solids.

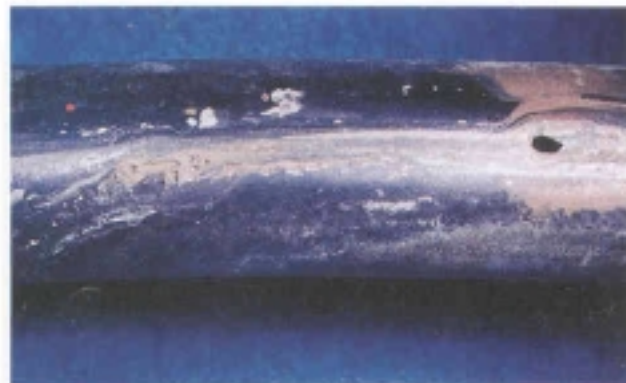
Figure 18 shows condensate grooving and the pitting attack. The condensate, which must be aggressive for this grooving to occur, wears away the protective oxide film as it drains from the tubing.

Controlling condensate pH and dissolved gases and cleaning the tube bundle outside surface to remove oils that prevent uniform wetting of the tube usually reduce the problem potential.

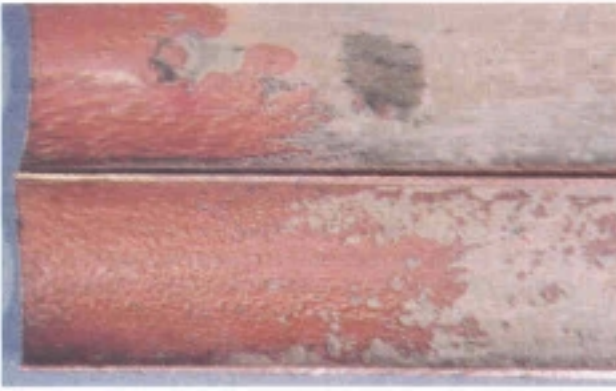
Figure 19 shows an erosion-corrosion attack. The bright copper surface at the tube entrance is erosion; the yellowish deposit inside the tube is corrosion.

Fig. 19. Erosion-corrosion attack on tube.

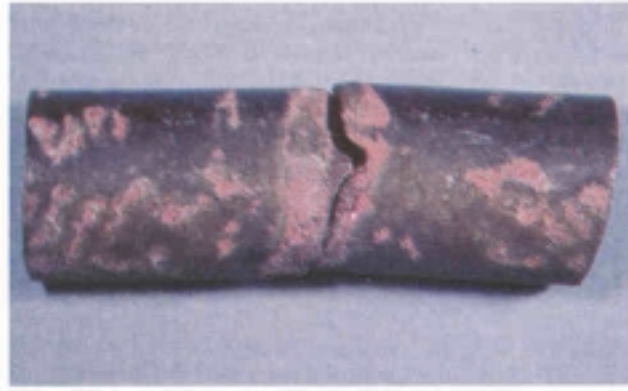
corrosion occurs, corrosion products and films block or retard further attack. However, in corrosion-fatigue, Fig. 20, cyclic stresses rupture the protected areas and make them permeable; this action subjects open areas to accelerated corrosion.

Fig. 20. Corrosion-fatigue attack on tube.

Improperly supported tube bundles in domestic hot water storage tanks often suffer from this kind of failure. Vibrations may not be very severe; however, resulting stresses act additively to the existing internal tensile stresses. The stress level is raised beyond the strength of the material and cracking or a fracture results.
