January 17th 2011 ~ Monday Morning Minutes:

Centrifugal Pumps – “Clipping the Tips”

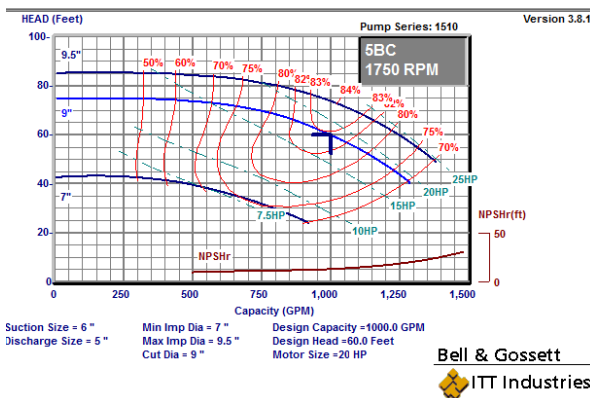
There is an existing Bell and Gossett model 1510-5BC with a capacity of 1000 GPM at 60 foot head using a 25 HP, 1750 RPM motor and a 9” cut impeller. This was a constant speed constant flow cooling pump. The owner wants to change one of the machines and the change is short term, so they want to keep the cost as low as possible. Changing out the pump would involve re-piping and new electrical causing down time and a great deal of cost for an operation which will change in the fall. The balance contractor indicated **they were short** on head. The renovation required 80 feet at the 1000 GPM flow. What could they do?

Clearly by changing the impeller to 9-1/2” the capacity will be increased to 1000 GPM at 74 feet on this curve. The next thing could be to look at a change in the motor. A premium efficiency 25 HP motor would be 1785 RPM and this would raise the head to 78 feet at 1000 GPM and be very close to the full load amps.

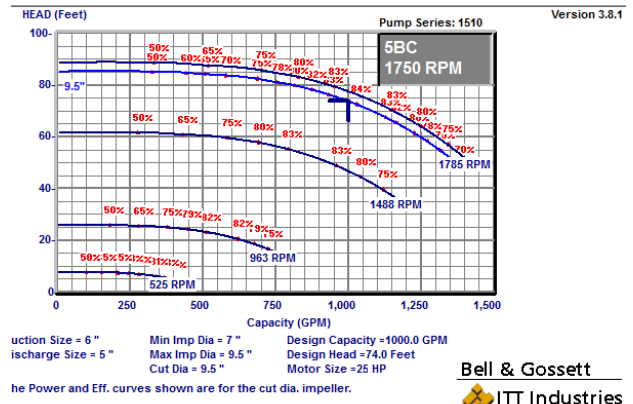
The last item is a little known procedure referred to by many names but we call it, “*clipping the tips*”. An impeller has a series of vanes shown in the figure below. If we under file the **impeller, removing** some of the brass, there is a larger area between the “*Tips*” of the impeller vanes. This causes a slightly higher discharge head. Based on experience at Bell and Gossett we can expect to get 2% to 4% higher head as a result of this change.
